Subject: The Highlands at Warner Springs
(TM 5450)
Warner Springs area,
San Diego County, California
GEOLOGIC INVESTIGATION

GEOLOGIC INVESTIGATION THE HIGHLANDS AT WARNER SPRINGS SAN DIEGO COUNTY, CALIFORNIA

Subject: The Highlands at Warner Springs
Warner Springs area,
San Diego County, California
(TM 5450)
(Addendum to Report of Geologic Investigation
dated January 23, 2006)

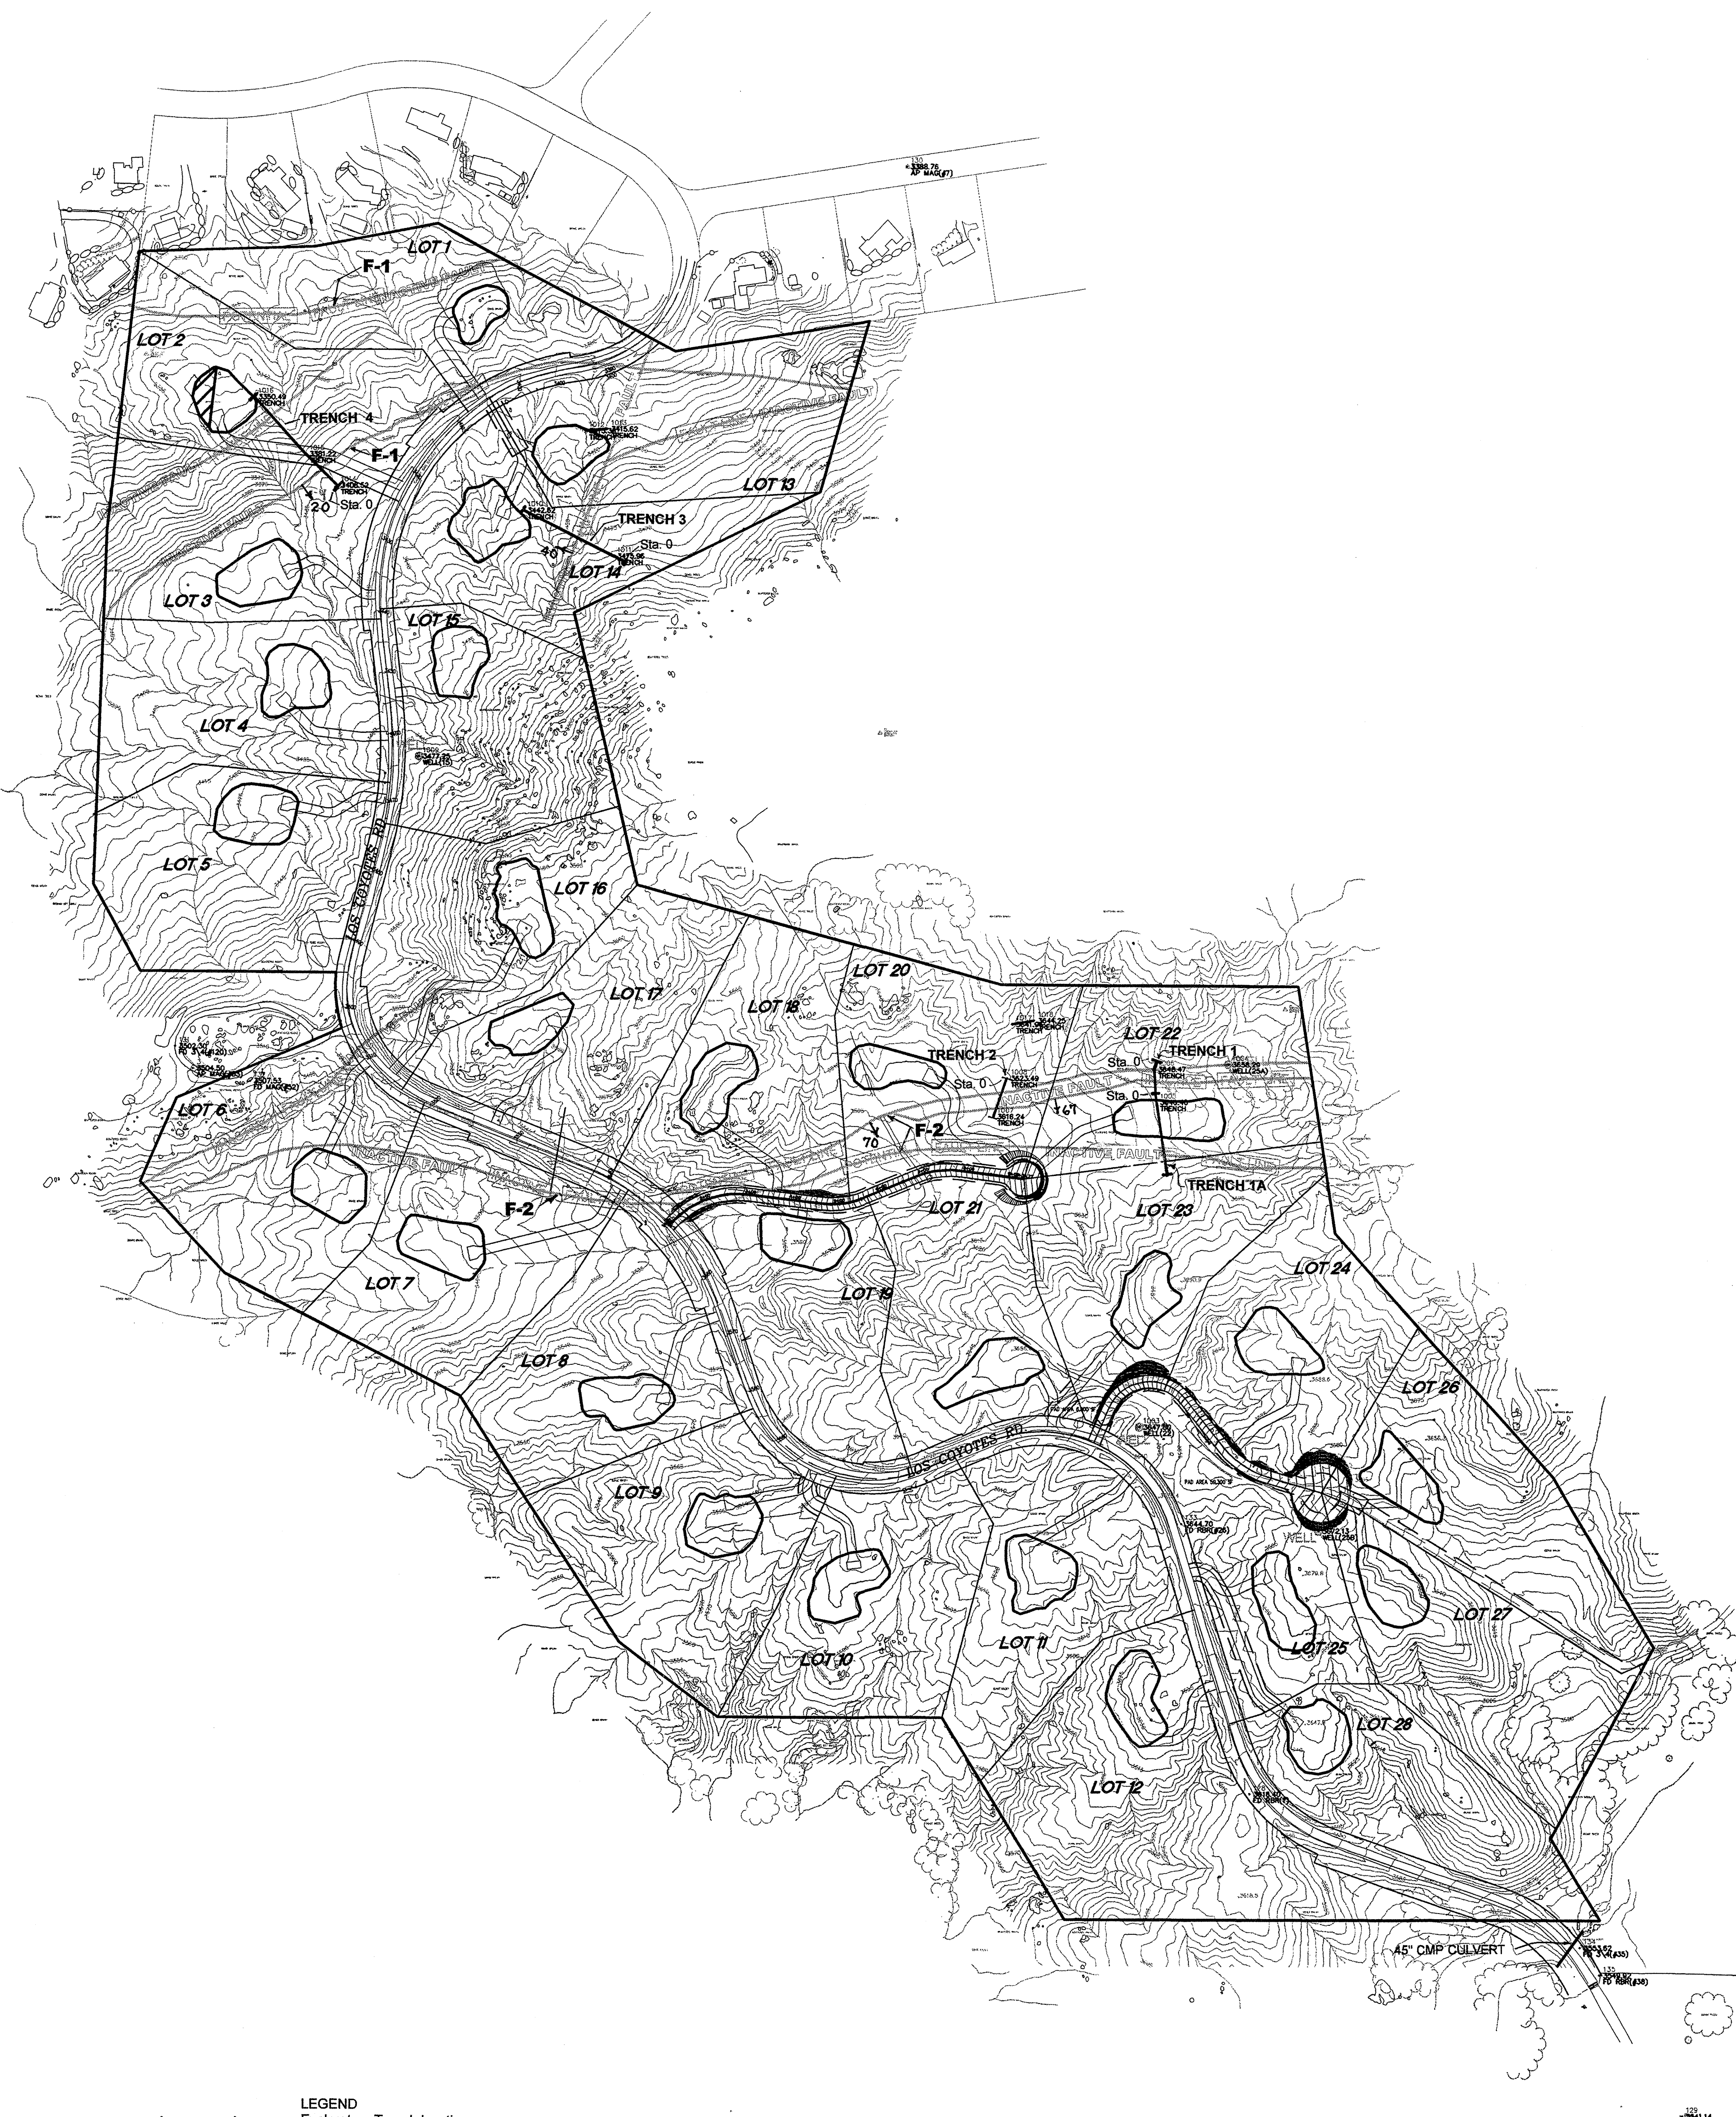
PLATE 1

1. It is concluded on the basis of evidence presented in the appendix of this report that none of the faults depicted on Plate I exhibit evidence of Holocene activity. Based on the petrographic evidence presented in the appendix, it is concluded that all faulting on the site, including relatively minor faults not examined petrographically, are likely contemporaneous with intrusion of pegmatite dikes during early to mid-Cretaceous time. It is also concluded the faults are not a constraint to development of the site and that structural setbacks are not required.

2. The fault investigated by Trench 3 (Lots 13 and 14) as well as the short fault segment extending from Lot 6 to the vicinity of Lot 16 are minor faults that either die out on site or are not visible as vegetation or topographic lineaments. Accordingly, it is concluded they have not likely been active during the Holocene and no structural setbacks are recommended.
